CERTIFICATION OF CLOSURE

HAMILTON
TECHNOLOGY INC

Re: Hamilton Technology, Inc.
(Queen Street Facility)

Closure Plan for Hazardous
Waste Storage Facility

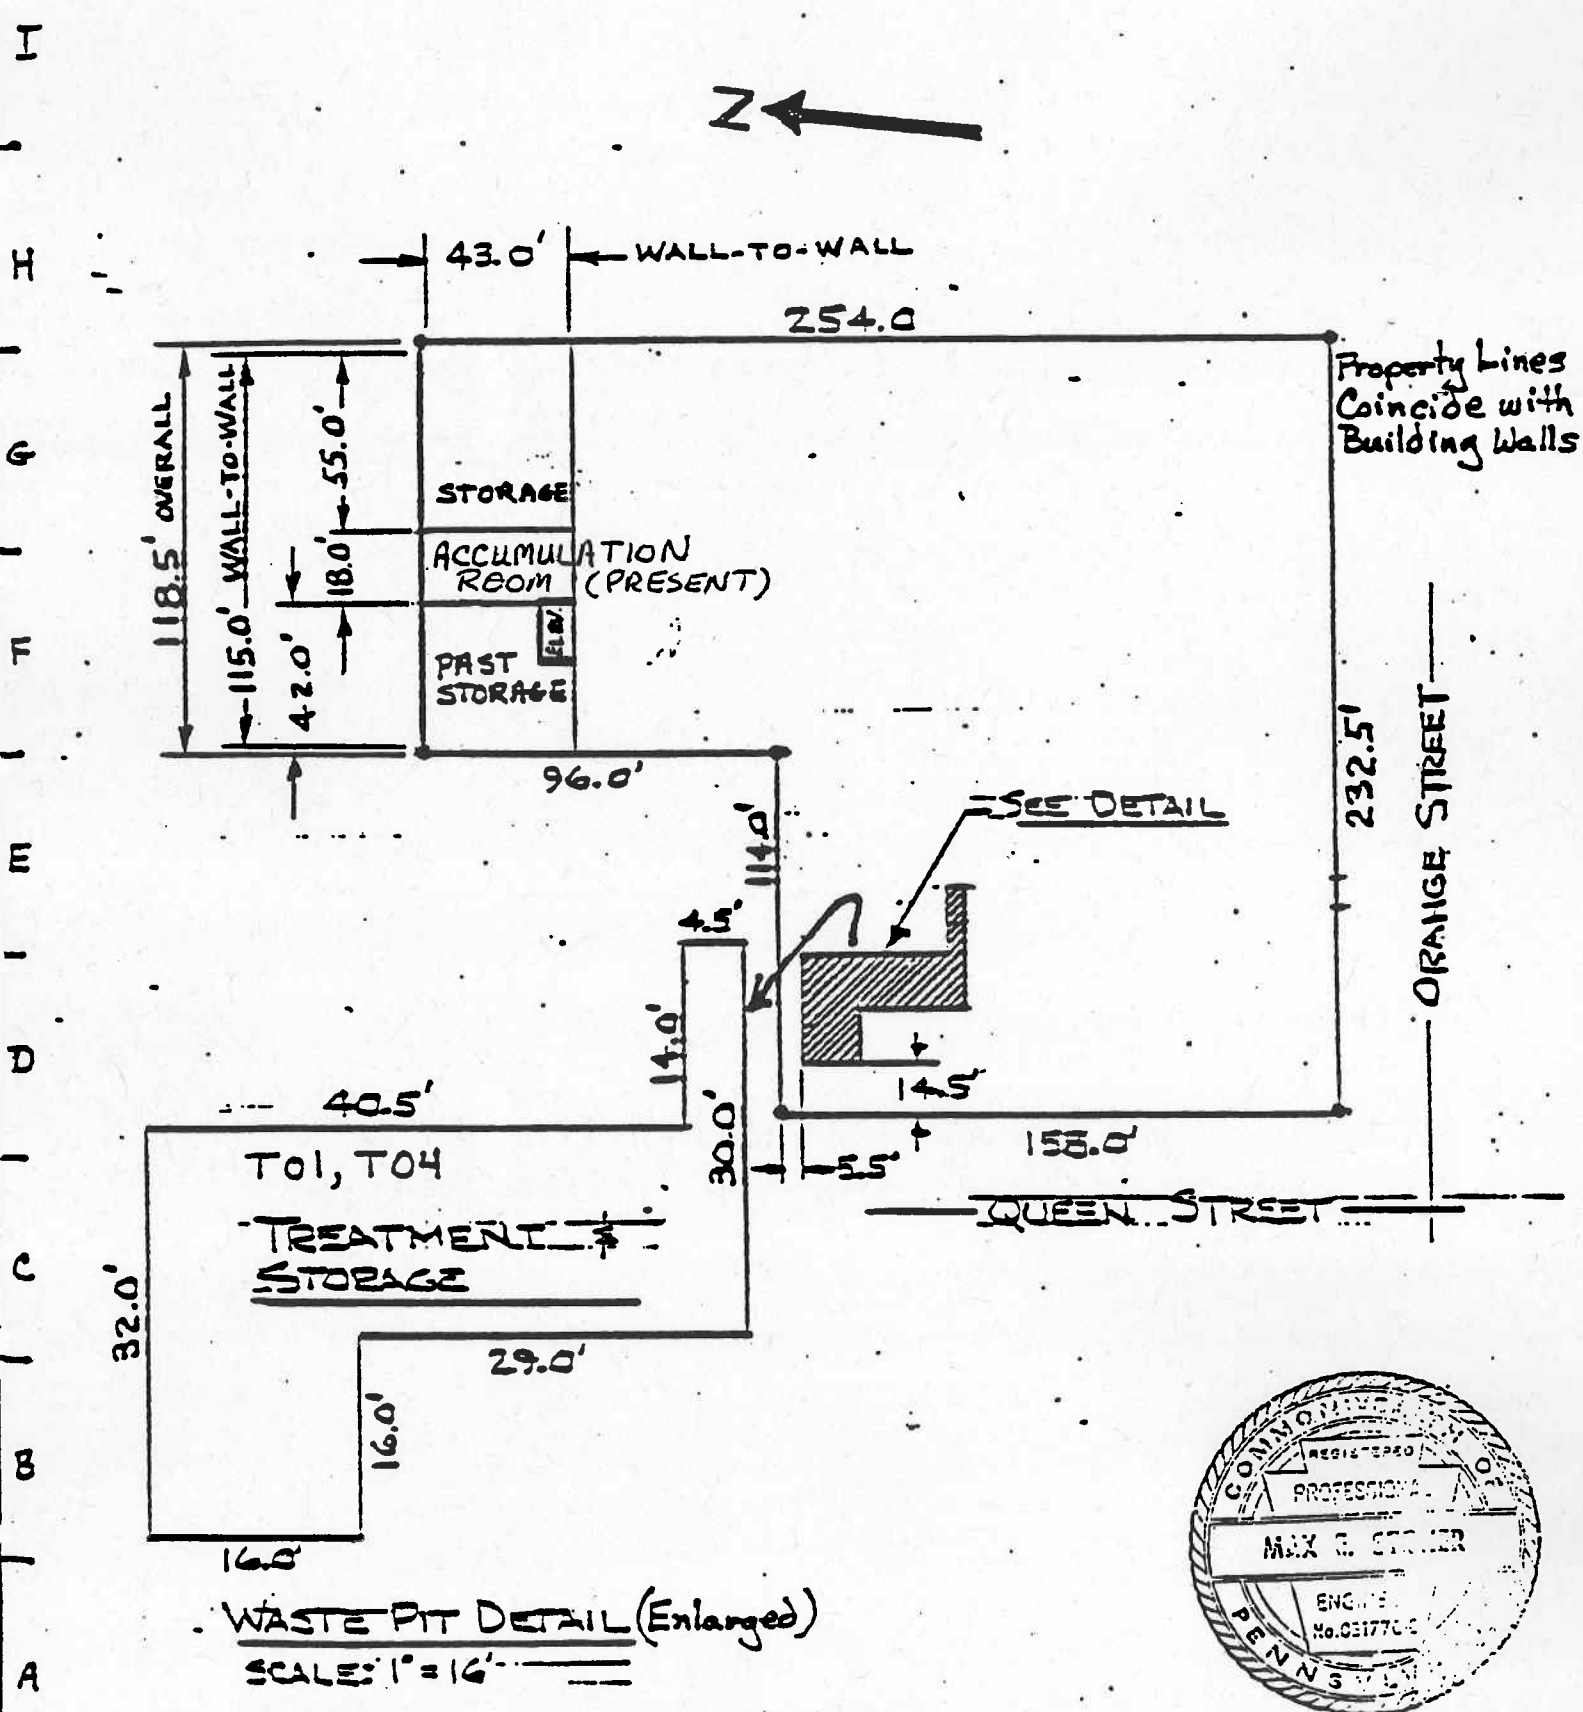
This Closure Plan is being submitted to formally "close" a room in this facility that was used for hazardous waste storage during 1982 and part of 1983 when the company first moved to this location. The location of the room is shown on the attached layout drawing and is labeled "Past Storage." Two other areas, labeled "Storage" and "Treatment and Storage", were never used for hazardous waste storage even though the Part A application originally designated them as such. We are not, therefore, submitting Closure Plans for them since they were not used for storage. The "Waste Pit" is used for treatment of wastewater and has a "Permit by Rule" status for that operation.

Currently, Hamilton Technology is operating as a generator, and we are accumulating waste for less than 90 days in a room labeled "Accumulation Room" on the layout drawing.
